# Access Compliance Report Public Rights-of-Way (Curb Ramps)

Main Street: VANCOUVER\_DR Cross Street: HARVEST\_LN Location: NW

ADA ID: RPRK210927165654 Ramp Type: Type 6 - Directional 1 Initial Pass/Fail: Pass Overall Compliance: No Severity Score: 2

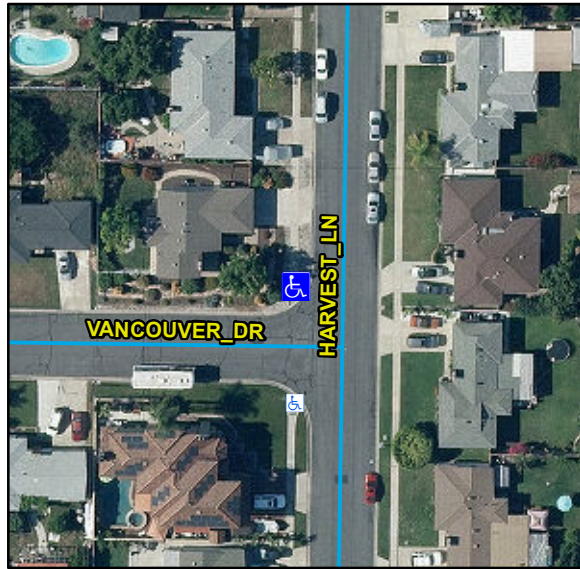
| Compliance | Description | Data | Compliance | Description | Data |
|---|---|---|---|---|---|
| No | Grade Break | No | N/A | Flare Type RT | |
| No | Landing Run Slope (%) | 2.3 | | DWS Offset Type | Multiple |
| No | Gutter Cross Slope (%) | 6.2 | | Parallel Ramp Side | Left |

Remove & Replace Entire Ramp. Remove & Replace Gutter.
