# Access Compliance Report Public Rights-of-Way (Curb Ramps)

Main Street: VANCOUVER\_DR Cross Street: HARVEST\_LN Location: S

ADA ID: RPRK210927170137 Ramp Type: Type 7 - Directional 2 Initial Pass/Fail: Fail Overall Compliance: No Severity Score: 16

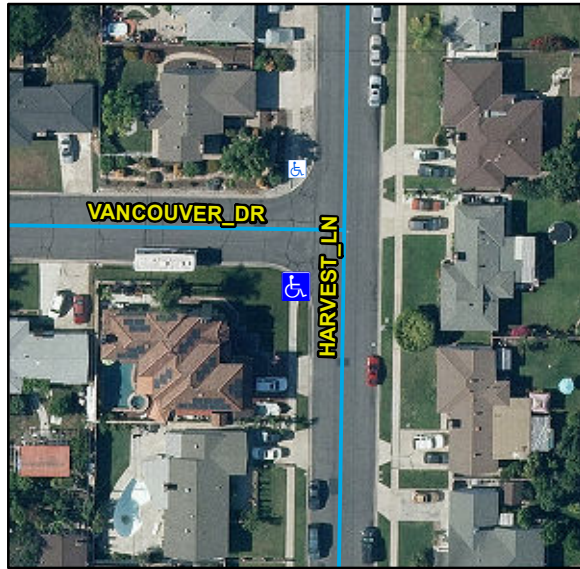
| Compliance | Description | Data | Compliance | Description | Data |
|---|---|---|---|---|---|
| No | Ramp Run Slope (%) | 10.7 | N/A | Flare Slope LT (%) | N/A |
| No | Ramp Cross Slope (%) | 2.6 | N/A | Flare Traversable LT | N/A |

Remove & Replace Entire Ramp.

R204.3, R304.2.2, R304.5.3, STD 1115
