# Access Compliance Report Public Rights-of-Way (Curb Ramps)

Main Street: GILBERT\_ST Cross Street: BALL\_RD Location: NE

ADA ID: RPRK210927171721 Ramp Type: Type 1 - Perpendicular Diagonal Initial Pass/Fail: Pass Overall Compliance: No Severity Score: 28

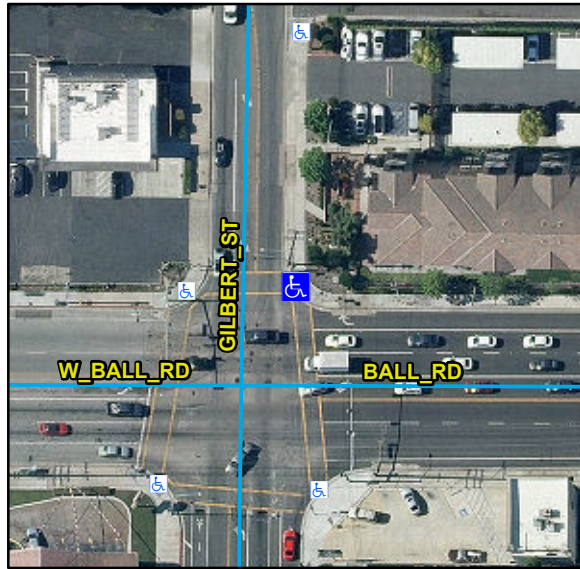
| Compliance | Description | Data | Compliance | Description | Data |
|---|---|---|---|---|---|
| No | Landing Width (in) | N/A | Yes | Flare Slope RT (%) | 7.3 |
| No | Landing Run Slope (%) | N/A | N/A | Flare Traversable RT | Yes |
| No | Landing Cross Slope (%) | N/A | No | DWS Provided | No |
| No | Gutter Ponding | Yes | Yes | Curb Slope | 0.7 |
| No | Gutter Lip Height (in) | 0.5 | | Road Run Slope (%) | 3.4 |
| No | Gutter Run Slope (%) | 12.1 | | Road Cross Slope (%) | 1 |

Remove & Replace Curb Ramp With Two New Directional Ramps or Equivalent. Remove & Replace Gutter. Utility Present.

R304.2.1, R304.2.2-Perp, R304.3.2-Para, R304.5.3, R305, R302.7, R302.7.2, R304.5.4, STD 1115
