# Access Compliance Report Public Rights-of-Way (Curb Ramps)

Main Street: W BALL RD Cross Street: GILBERT ST Location: NW

ADA ID: RPRK210927172541 Ramp Type: Type 1 - Perpendicular Diagonal Initial Pass/Fail: Fail Overall Compliance: No Severity Score: 32

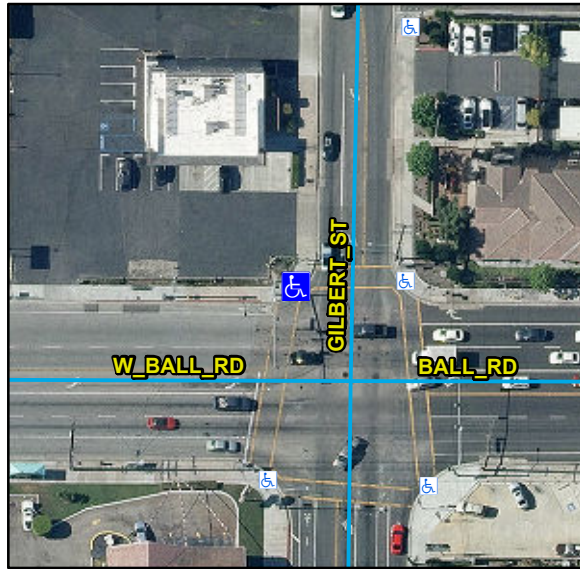
| Compliance | Description | Data | Compliance | Description | Data |
|---|---|---|---|---|---|
| No | Ramp Run Slope (%) | 13 | N/A | Flare Slope LT (%) | N/A |

Remove & Replace Curb Ramp With Two New Directional Ramps or Equivalent.
