# Access Compliance Report Public Rights-of-Way (Curb Ramps)

Main Street: GILBERT\_ST Cross Street: W BALL\_RD Location: SW

ADA ID: RPRK210927173130 Ramp Type: Type 1 - Perpendicular Diagonal Initial Pass/Fail: Pass Overall Compliance: No Severity Score: 10

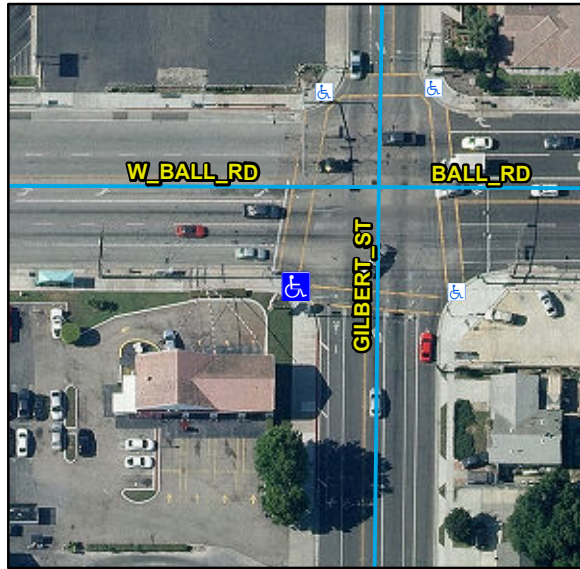
| Compliance | Description | Data | Compliance | Description | Data |
|---|---|---|---|---|---|
| Yes | Gutter Ponding | No | No | Curb Slope | 7.6 |
| No | Gutter Run Slope (%) | 12.1 | | Road Cross Slope (%) | 0.5 |

Remove & Replace Curb Ramp With Two New Directional Ramps or Equivalent. Remove & Replace Gutter. Utility Present.

R304.2.2, R304.2.1, R304.5.4, STD 1115
