# Access Compliance Report Public Rights-of-Way (Curb Ramps)

Main Street: BALL\_RD Cross Street: GILBERT\_ST Location: SE

ADA ID: RPRK210927174021 Ramp Type: Type 1 - Perpendicular Diagonal Initial Pass/Fail: Pass Overall Compliance: No Severity Score: 6

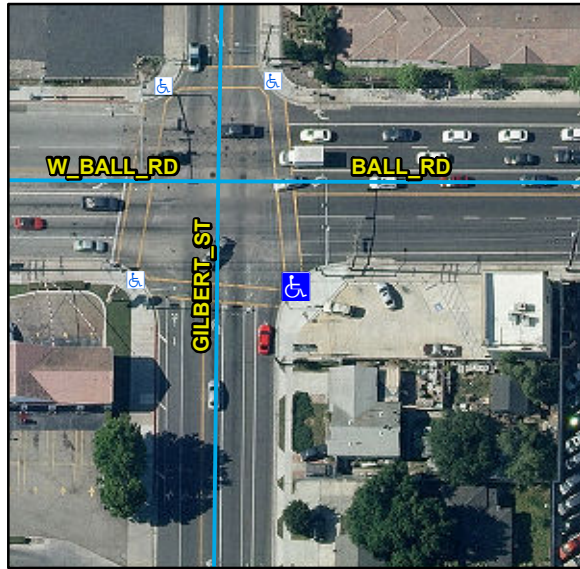
| Compliance | Description | Data | Compliance | Description | Data |
|---|---|---|---|---|---|
| No | Ramp Cross Slope (%) | 3 | N/A | Flare Traversable LT | No |
| No | Gutter Run Slope (%) | 8.1 | | Road Cross Slope (%) | 8.2 |

Remove & Replace Curb Ramp With Two New Directional Ramps or Equivalent. Remove & Replace Gutter.

R304.5.3, R304.5.4, STD 1115
