# Access Compliance Report

## Public Rights-of-Way

### (Curb Ramps)

Main Street: DALE\_ST Cross Street: ORANGEWOOD\_AVE Location: NE

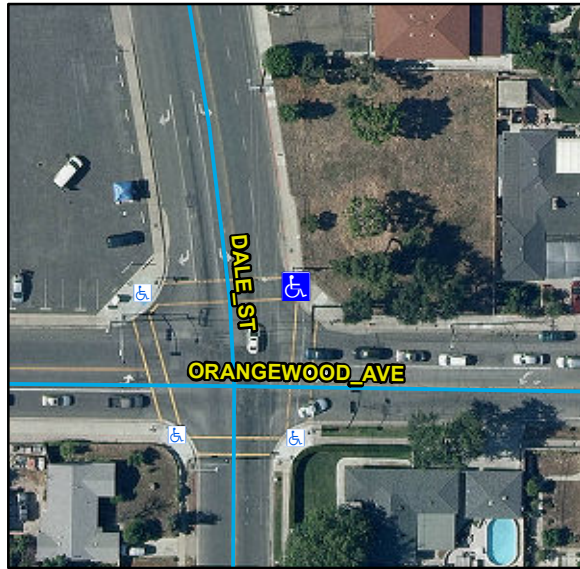
ADA ID: RPRK210928112019 Ramp Type: Type 1 - Perpendicular Diagonal Initial Pass/Fail: Fail Overall Compliance: No Severity Score: 30

| Compliance | Description | Data | Compliance | Description | Data |
|---|---|---|---|---|---|
| No | Ramp Run Slope (%) | 14.2 | N/A | Flare Slope LT (%) | N/A |
| N/A | Clear Space To Crosswalk (in) | 0 | N/A | DWS Offset Right (in) | N/A |
| No | Gutter Lip Height (in) | 1 | | Road Run Slope (%) | 2.9 |

**Remove & Replace Curb Ramp With Two New Directional Ramps or Equivalent. Restripe Crosswalk. Grind Gutter Lip.**

**R204.3, R304.2.2, R302.7.2, STD 1115**
