# Access Compliance Report Public Rights-of-Way (Curb Ramps)

Main Street: ORANGEWOOD\_AVE Cross Street: DALE\_ST Location: NW

ADA ID: RPRK210928112813 Ramp Type: Type 1 - Perpendicular Diagonal Initial Pass/Fail: Fail Overall Compliance: No Severity Score: 2

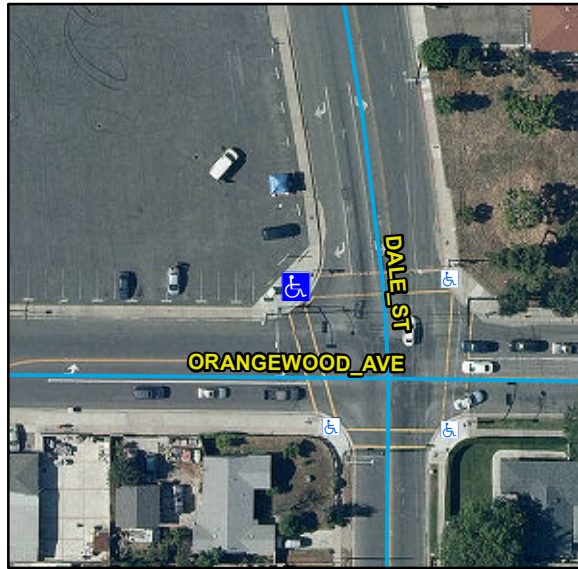
| Compliance | Description | Data | Compliance | Description | Data |
|---|---|---|---|---|---|
| No | Ramp Cross Slope (%) | 2.5 | N/A | Flare Traversable LT | N/A |
| N/A | Ramp Inside Crosswalk 1 | Yes | Yes | Ramp Inside Crosswalk 2 | Yes |

**Remove & Replace Curb Ramp With Two New Directional Ramps or Equivalent.**

**R204.3, R304.5.3, STD 1115**
