# Access Compliance Report Public Rights-of-Way (Curb Ramps)

Main Street: ORANGEWOOD\_AVE Cross Street: MOSSLER\_ST Location: NE

ADA ID: RPRK210928120021 Ramp Type: Type 1 - Perpendicular Initial Pass/Fail: Fail Overall Compliance: No Severity Score: 2

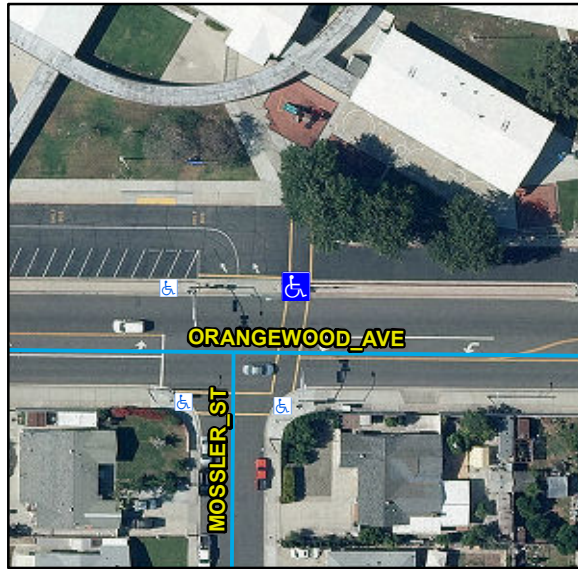
| Compliance | Description | Data | Compliance | Description | Data |
|---|---|---|---|---|---|
| No | Ramp Cross Slope (%) | 2.2 | N/A | Flare Traversable LT | N/A |
| N/A | Gutter Ponding | N/A | No | Curb Slope | 10.5 |
| No | Gutter Lip Height (in) | 0.25 | | Road Run Slope (%) | N/A |

Remove & Replace Entire Ramp.

R304.2.2, R204.3, R304.5.3, R302.7.2, STD 1115
