# Access Compliance Report Public Rights-of-Way (Curb Ramps)

Main Street: ORANGEWOOD\_AVE Cross Street: NEARING\_DR Location: SE

ADA ID: RPRK210928121153 Ramp Type: Type 1 - Perpendicular Diagonal Initial Pass/Fail: Pass Overall Compliance: No Severity Score: 0

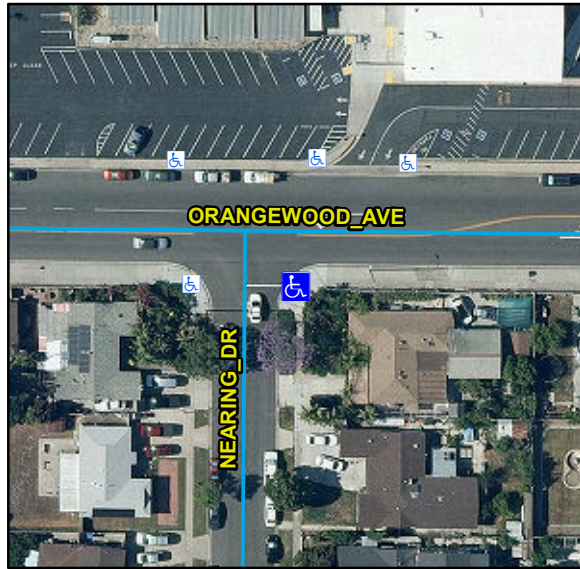
| Compliance | Description | Data | Compliance | Description | Data |
|---|---|---|---|---|---|
| Yes | Gutter Ponding | No | No | Curb Slope | 6 |
| No | Gutter Cross Slope (%) | 3.9 | | | |

Remove & Replace Curb Ramp With Two New Directional Ramps or Equivalent. Remove & Replace Gutter.

R304.2.2, R304.2.1, R304.5.3, STD 1115
