# Access Compliance Report

## Public Rights-of-Way

### (Curb Ramps)

Main Street: **YORKSHIRE\_AVE** Cross Street: **NEARING\_DR** Location: **SE**

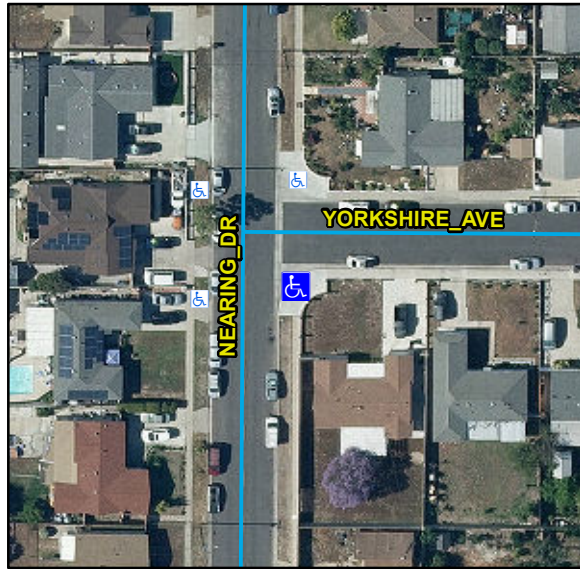
ADA ID: **RPRK210928130702** Ramp Type: **Type 1 - Perpendicular Diagonal Initial Pass/Fail: Fail** Overall Compliance: **No** Severity Score: **15**

| Compliance | Description | Data | Compliance | Description | Data |
|---|---|---|---|---|---|
| <b>No</b> | Ramp Run Slope (%) | <b>10.4</b> | <b>N/A</b> | Flare Slope LT (%) | <b>N/A</b> |

**Remove & Replace Curb Ramp With Two New Directional Ramps or Equivalent.**

**R304.2.2, STD 1115**
