# Access Compliance Report Public Rights-of-Way (Curb Ramps)

Main Street: TWANA\_DR Cross Street: DALE\_ST Location: SE

ADA ID: RPRK210928132020 Ramp Type: Type 1 - Perpendicular Diagonal Initial Pass/Fail: Pass Overall Compliance: No Severity Score: 20

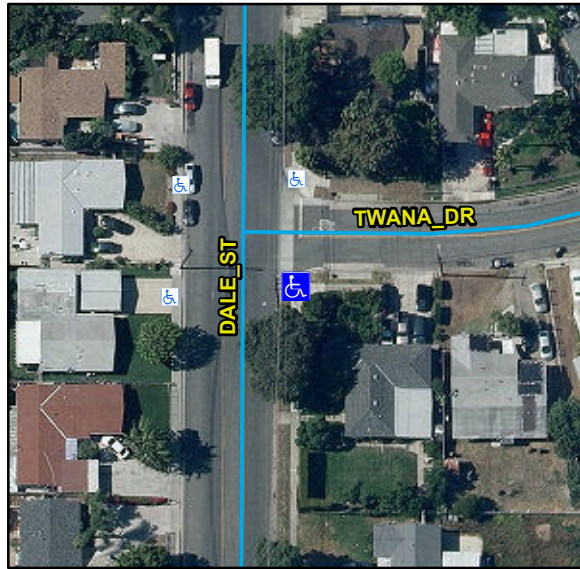
| Compliance | Description | Data | Compliance | Description | Data |
|---|---|---|---|---|---|
| No | Landing Run Slope (%) | 2.2 | N/A | Flare Traversable RT | No |
| No | Landing Cross Slope (%) | 4.7 | Yes | DWS Provided | Yes |
| No | Gutter Lip Height (in) | 2 | | Road Run Slope (%) | 3 |
| No | Gutter Run Slope (%) | 6 | | Road Cross Slope (%) | 1.6 |
| No | Gutter Cross Slope (%) | 2.3 | | | |

Remove & Replace Landing. Remove & Replace Gutter.
