# Access Compliance Report Public Rights-of-Way (Curb Ramps)

Main Street: NEARING\_DR Cross Street: AUGUSTA\_DR Location: NE

ADA ID: RPRK210928134821 Ramp Type: Type 1 - Perpendicular Diagonal Initial Pass/Fail: Fail Overall Compliance: No Severity Score: 16

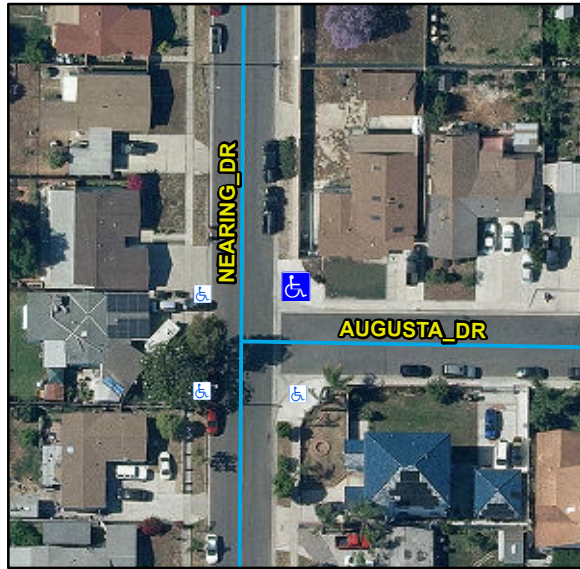
| Compliance | Description | Data | Compliance | Description | Data |
|---|---|---|---|---|---|
| No | Ramp Run Slope (%) | 9.6 | N/A | Flare Slope LT (%) | N/A |
| No | Ramp Cross Slope (%) | 2.3 | N/A | Flare Traversable LT | N/A |
| | Crossing 1 Slope (%) | 9.7 | | Crossing 2 Slope (%) | 1.4 |

**Remove & Replace Curb Ramp With Two New Directional Ramps or Equivalent.**

**R304.2.2, R304.5.3, STD 1115**
