# Access Compliance Report Public Rights-of-Way (Curb Ramps)

Main Street: AUGUSTA\_DR Cross Street: NEARING\_DR Location: SE

ADA ID: RPRK210928135008 Ramp Type: Type 1 - Perpendicular Diagonal Initial Pass/Fail: Fail Overall Compliance: No Severity Score: 15

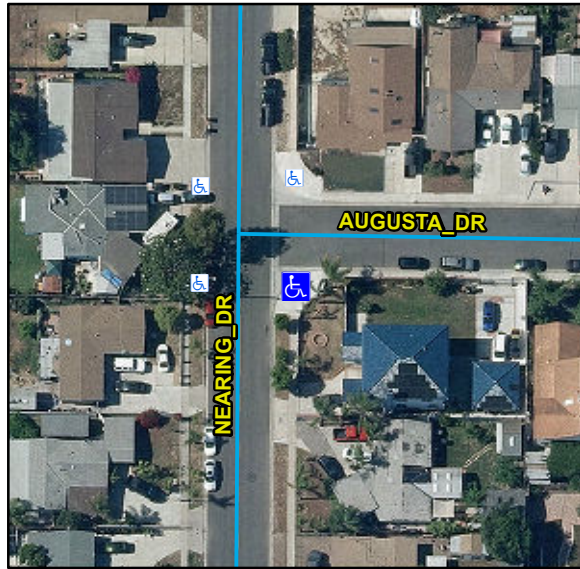
| Compliance | Description | Data | Compliance | Description | Data |
|---|---|---|---|---|---|
| No | Ramp Run Slope (%) | 9.4 | N/A | Flare Slope LT (%) | N/A |

**Remove & Replace Curb Ramp With Two New Directional Ramps or Equivalent.**

**R304.2.2, STD 1115**
