# Access Compliance Report Public Rights-of-Way (Curb Ramps)

Main Street: SOMERS\_DR Cross Street: NEARING\_DR Location: NW

ADA ID: RPRK210928141407 Ramp Type: Type 1 - Perpendicular Diagonal Initial Pass/Fail: Pass Overall Compliance: No Severity Score: 2

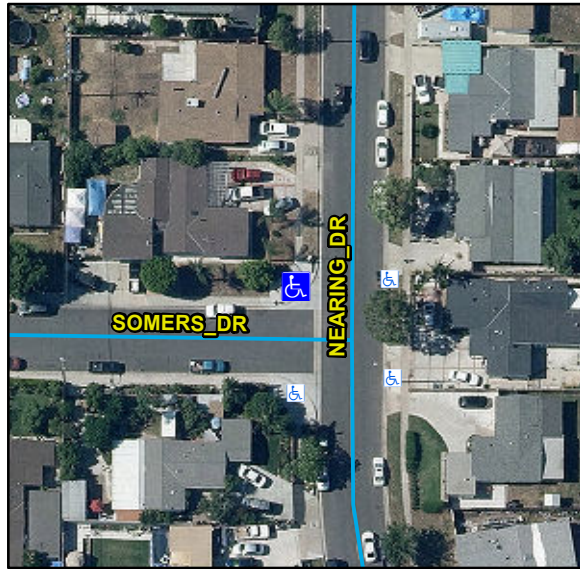
| Compliance | Description | Data | Compliance | Description | Data |
|---|---|---|---|---|---|
| No | Ramp Cross Slope (%) | 2.1 | N/A | Flare Traversable LT | No |
| No | Landing Run Slope (%) | 2.7 | N/A | Flare Traversable RT | No |
| No | Landing Cross Slope (%) | 2.7 | Yes | DWS Provided | Yes |
| No | Gutter Cross Slope (%) | 3.9 | | | |

Remove & Replace Curb Ramp With Two New Directional Ramps or Equivalent. Remove & Replace Gutter.

R304.2.2, R304.5.3, R304.2.2-Perp, R304.3.2-Para, STD 1115
