# Access Compliance Report Public Rights-of-Way (Curb Ramps)

Main Street: NEARING\_DR Cross Street: SOMERS\_DR Location: SW

ADA ID: RPRK210928141737 Ramp Type: Type 1 - Perpendicular Diagonal Initial Pass/Fail: Fail Overall Compliance: No Severity Score: 2

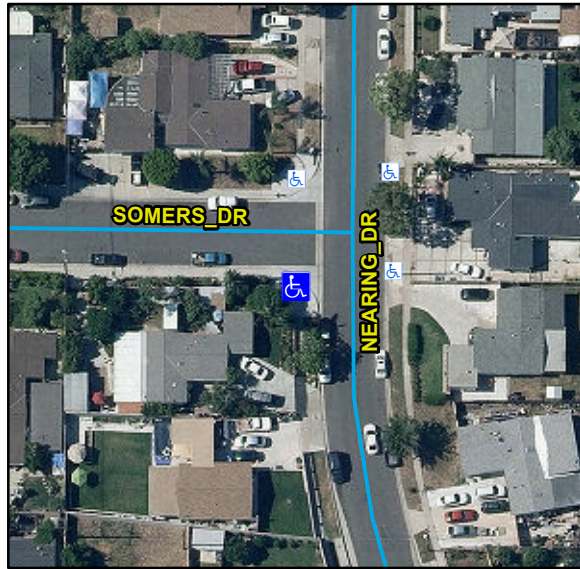
| Compliance | Description | Data | Compliance | Description | Data |
|---|---|---|---|---|---|
| No | Ramp Cross Slope (%) | 5 | N/A | Flare Traversable LT | N/A |

**Remove & Replace Curb Ramp With Two New Directional Ramps or Equivalent.**

**R304.5.3, STD 1115**
