# Access Compliance Report Public Rights-of-Way (Curb Ramps)

Main Street: CHAPMAN\_AVE Cross Street: BEACH\_BLVD Location: E

ADA ID: RPRK210928152105 Ramp Type: Type 1 - Perpendicular Diagonal Initial Pass/Fail: Fail Overall Compliance: No Severity Score: 32

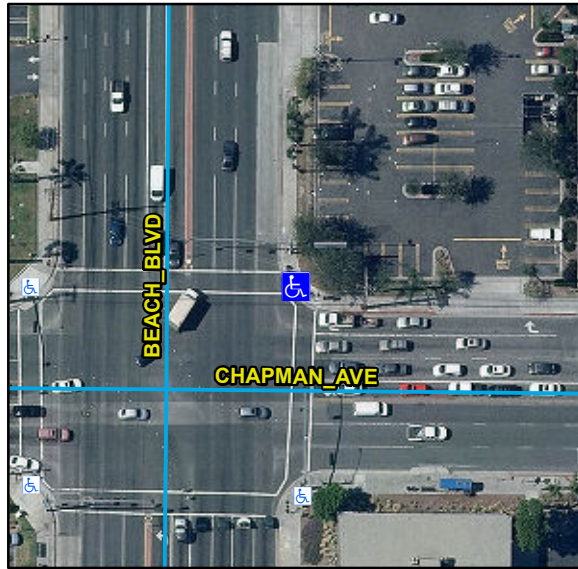
| Compliance | Description | Data | Compliance | Description | Data |
|---|---|---|---|---|---|
| No | Ramp Run Slope (%) | 14.1 | N/A | Flare Slope LT (%) | N/A |
| No | Ramp Cross Slope (%) | 3.5 | N/A | Flare Traversable LT | N/A |
| No | Gutter Lip Height (in) | 0.25 | | Road Run Slope (%) | 2.5 |

Remove & Replace Curb Ramp With Two New Directional Ramps or Equivalent. Grind Gutter Lip.
