# Access Compliance Report Public Rights-of-Way (Curb Ramps)

Main Street: CHAPMAN\_AVE Cross Street: CHAPMAN\_AVE Location: N

ADA ID: RPRK210928153932 Ramp Type: Type 1 - Perpendicular Initial Pass/Fail: Fail Overall Compliance: No Severity Score: 16

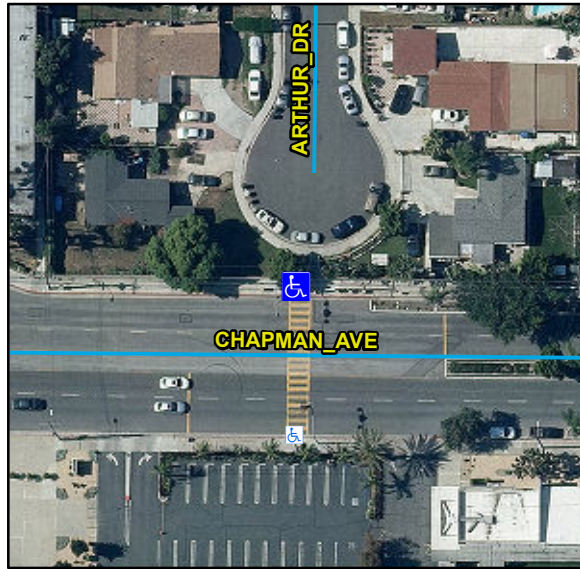
| Compliance | Description | Data | Compliance | Description | Data |
|---|---|---|---|---|---|
| No | Ramp Run Slope (%) | 10.1 | N/A | Flare Slope LT (%) | N/A |
| No | Ramp Cross Slope (%) | 2.3 | N/A | Flare Traversable LT | N/A |
| No | Gutter Lip Height (in) | 0.5 | | Road Run Slope (%) | N/A |

Remove & Replace Entire Ramp. Grind Gutter Lip.

R204.3, R304.2.2, R304.5.3, R302.7.2, STD 1115
