# Access Compliance Report Public Rights-of-Way (Curb Ramps)

Main Street: NEARING\_DR Cross Street: BUCHANAN\_DR Location: NE

ADA ID: RPRK210928172258 Ramp Type: Type 1 - Perpendicular Diagonal Initial Pass/Fail: Fail Overall Compliance: No Severity Score: 16

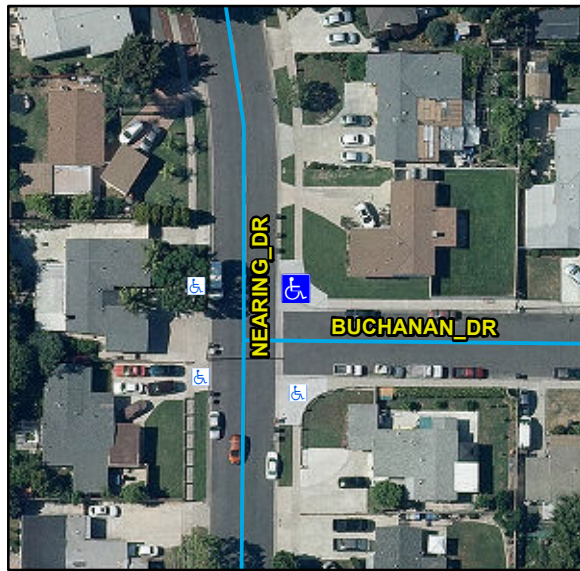
| Compliance | Description | Data | Compliance | Description | Data |
|---|---|---|---|---|---|
| No | Ramp Run Slope (%) | 10.5 | N/A | Flare Slope LT (%) | N/A |
| No | Ramp Cross Slope (%) | 3.5 | N/A | Flare Traversable LT | N/A |

Remove & Replace Curb Ramp With Two New Directional Ramps or Equivalent.

R304.2.2, R304.5.3, STD 1115
