# Access Compliance Report Public Rights-of-Way (Curb Ramps)

Main Street: BUCHANAN\_DR Cross Street: NEARING\_DR Location: SE

ADA ID: RPRK210928172509 Ramp Type: Type 1 - Perpendicular Diagonal Initial Pass/Fail: Fail Overall Compliance: No Severity Score: 16

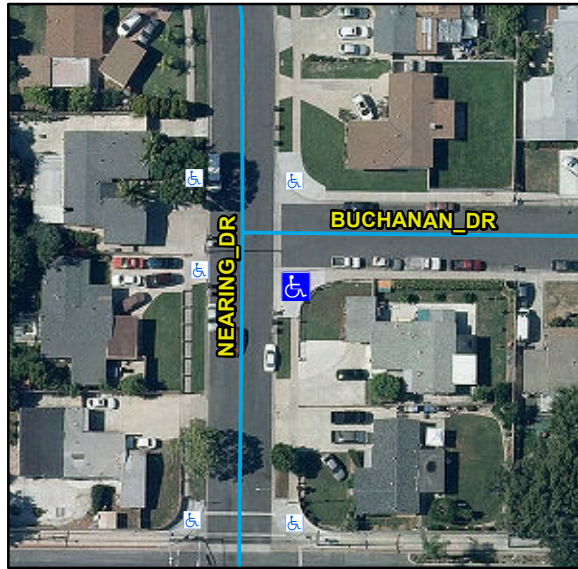
| Compliance | Description | Data | Compliance | Description | Data |
|---|---|---|---|---|---|
| No | Ramp Run Slope (%) | 10 | N/A | Flare Slope LT (%) | N/A |
| No | Ramp Cross Slope (%) | 2.2 | N/A | Flare Traversable LT | N/A |

Remove & Replace Curb Ramp With Two New Directional Ramps or Equivalent.

R304.2.2, R304.5.3, STD 1115
