# Access Compliance Report Public Rights-of-Way (Curb Ramps)

Main Street: NEARING\_DR Cross Street: CHAPMAN\_AVE Location: NE

ADA ID: RPRK210928174454 Ramp Type: Type 1 - Perpendicular Diagonal Initial Pass/Fail: Fail Overall Compliance: No Severity Score: 15

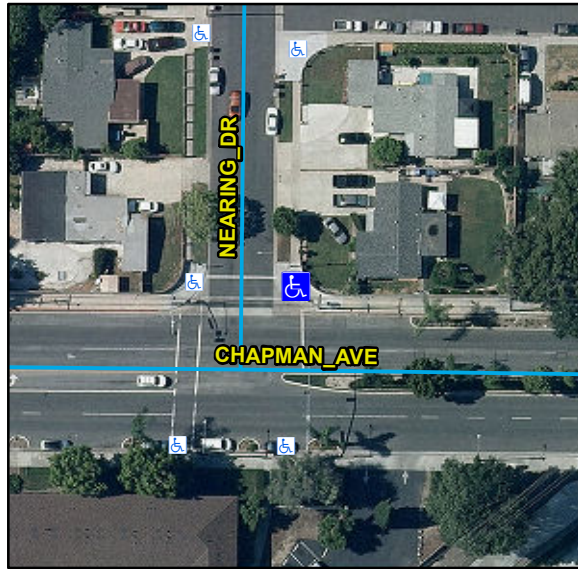
| Compliance | Description | Data | Compliance | Description | Data |
|---|---|---|---|---|---|
| No | Ramp Run Slope (%) | 10.6 | N/A | Flare Slope LT (%) | N/A |

**Remove & Replace Curb Ramp With Two New Directional Ramps or Equivalent.**

**R304.2.2, STD 1115**
