# Access Compliance Report Public Rights-of-Way (Curb Ramps)

Main Street: CHAPMAN\_AVE Cross Street: CHAPMAN\_AVE Location: SW

ADA ID: RPRK210928175244 Ramp Type: Type 1 - Perpendicular Diagonal Initial Pass/Fail: Fail Overall Compliance: No Severity Score: 15

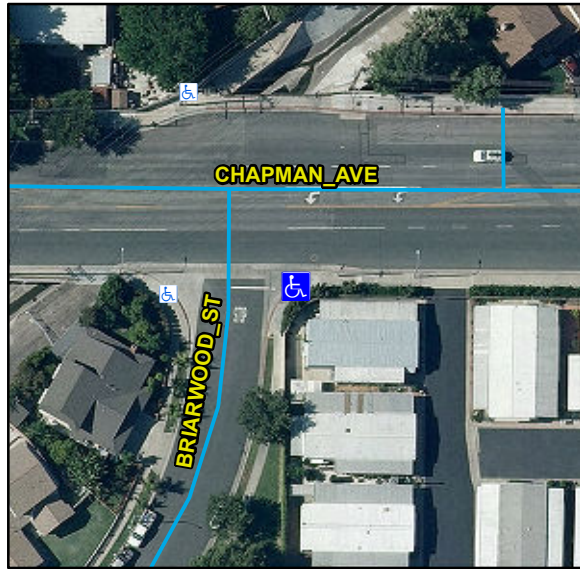
| Compliance | Description | Data | Compliance | Description | Data |
|---|---|---|---|---|---|
| No | Ramp Run Slope (%) | 9.6 | N/A | Flare Slope LT (%) | N/A |
| No | Gutter Lip Height (in) | 0.25 | | Road Run Slope (%) | 3 |

Remove & Replace Curb Ramp With Two New Directional Ramps or Equivalent. Grind Gutter Lip.

R204.3, R304.2.2, R302.7.2, STD 1115
