# Access Compliance Report Public Rights-of-Way (Curb Ramps)

**Main Street:** MARYLEE\_DR      **Cross Street:** CHAPMAN\_AVE      **Location:** SE

**ADA ID:** RPRK210928180613      **Ramp Type:** Type 1 - Perpendicular Diagonal Initial Pass/Fail: Pass      **Overall Compliance:** No      **Severity Score:** 28

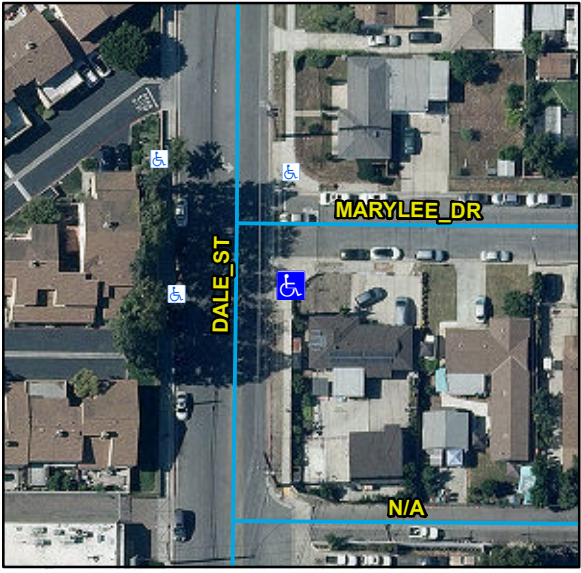
Compliance	Description	Data	Compliance	Description	Data
N/A	Ramp Length (in)	120	N/A	Flare Type LT	
Yes	Ramp Width (in)	48			Sloped
Yes	Ramp Run Slope (%)	6.1	N/A	Flare Slope LT (%)	8.4
Yes	Ramp Cross Slope (%)	0.8	N/A	Flare Traversable LT	No
N/A	Landing Present	No	N/A	Flare Type RT	
N/A	Landing Length (in)	N/A			Sloped
No	Landing Width (in)	N/A	No	Flare Slope RT (%)	11.6
No	Landing Run Slope (%)	N/A	N/A	Flare Traversable RT	Yes
No	Landing Cross Slope (%)	N/A	No	DWS Provided	No
N/A	Landing Movement Obstructed?	Yes	N/A	DWS Contrast	N/A
	Landing Movement Type	Curb	N/A	DWS Length (in)	N/A
N/A	Landing Shared	N/A	N/A	DWS Full Width	N/A
N/A	Clear Space	Yes	N/A	DWS Offset Left (in)	N/A
N/A	Clear Space To Crosswalk (in)	48	N/A	DWS Offset Right (in)	N/A
N/A	Marked Crosswalk 1	No	N/A	Marked Crosswalk 2	No
	Crossing 1 Direction	N		Crossing 2 Direction	W
	Marked Crosswalk 1 Width (in)	N/A		Marked Crosswalk 2 Width (in)	N/A

N/A	Ramp Inside Crosswalk 1	N/A	Yes	Ramp Inside Crosswalk 2	N/A
	Crossing 1 Slope (%)	8.5		Crossing 2 Slope (%)	5.9
	Crossing 1 Cross Slope (%)	3.6		Crossing 2 Cross Slope (%)	1.2
Yes	Gutter Ponding	No	Yes	Curb Slope	0.9
Yes	Gutter Lip Height (in)	0		Road Run Slope (%)	3.4
No	Gutter Run Slope (%)	7.2		Road Cross Slope (%)	6.5
No	Gutter Cross Slope (%)	2.2			
Yes	Overall Surface Condition:	Acceptable	Yes	Perp Joint Present	Yes
	Cross Gutter Present?	Yes		Spandrel Present?	Yes
	Replace Cross Gutter?	No		Replace Spandrel?	No

**Possible Solutions:**  
**Remove & Replace Curb Ramp With Two New Directional Ramps or Equivalent. Remove & Replace Gutter.**
