# Access Compliance Report Public Rights-of-Way (Curb Ramps)

Main Street: NEWLAND\_ST Cross Street: BOLSA\_AVE Location: SW

ADA ID: RPRK210929130641 Ramp Type: Type 1 - Perpendicular Diagonal Initial Pass/Fail: Pass Overall Compliance: No Severity Score: 8

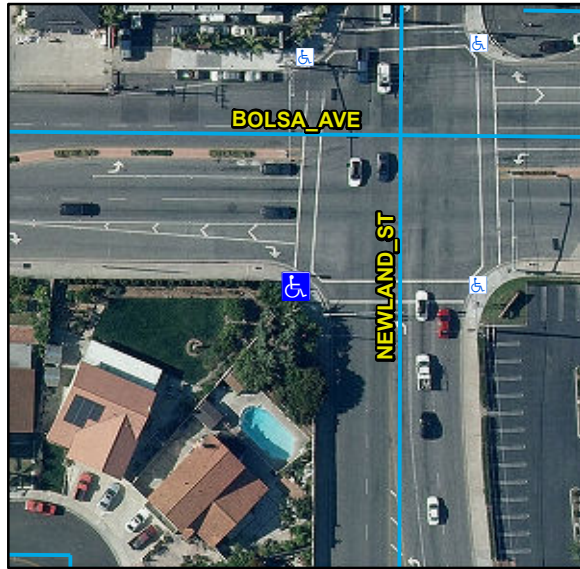
| Compliance | Description | Data | Compliance | Description | Data |
|---|---|---|---|---|---|
| No | Landing Cross Slope (%) | 4.5 | Yes | DWS Provided | Yes |
| No | Gutter Ponding | Yes | No | Curb Slope | 5.6 |
| No | Gutter Cross Slope (%) | 2.6 | | | |

Remove & Replace Curb Ramp With Two New Directional Ramps or Equivalent. Remove & Replace Gutter.
