Access Compliance Report Public Rights-of-Way (Curb Ramps)

Main Street: **BOLSA_AVE** Cross Street: **JEFFERSON_ST** Location: **NW**

ADA ID: **RPRK210929133718** Ramp Type: **Type 1 - Perpendicular Diagonal** Initial Pass/Fail: **Pass** Overall Compliance: **No** Severity Score: **6**

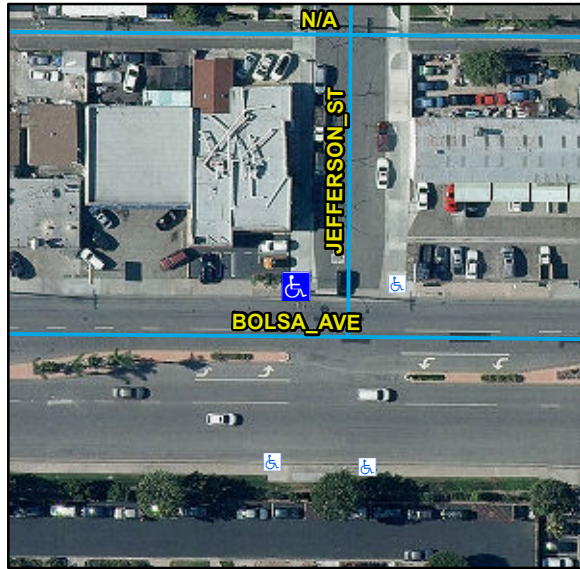
Compliance	Description	Data	Compliance	Description	Data
N/A	Ramp Length (in)	97	N/A	Flare Type LT	
Yes	Ramp Width (in)	48			Sloped
Yes	Ramp Run Slope (%)	3.8	N/A	Flare Slope LT (%)	3.5
Yes	Ramp Cross Slope (%)	0.5	N/A	Flare Traversable LT	No
N/A	Landing Present	Yes	N/A	Flare Type RT	
N/A	Landing Length (in)	35			Sloped
Yes	Landing Width (in)	48	N/A	Flare Slope RT (%)	4.6
No	Landing Run Slope (%)	4.1	N/A	Flare Traversable RT	No
No	Landing Cross Slope (%)	2.8	Yes	DWS Provided	Yes
N/A	Landing Movement Obstructed?	Yes	Yes	DWS Contrast	Yes
	Landing Movement Type	Wall	Yes	DWS Length (in)	37
N/A	Landing Shared	No	Yes	DWS Full Width	Yes
N/A	Clear Space	Yes	Yes	DWS Offset Left (in)	0
N/A	Clear Space To Crosswalk (in)	48	Yes	DWS Offset Right (in)	N/A
N/A	Marked Crosswalk 1	No	N/A	Marked Crosswalk 2	No
	Crossing 1 Direction	S		Crossing 2 Direction	E
	Marked Crosswalk 1 Width (in)	N/A		Marked Crosswalk 2 Width (in)	N/A

N/A	Ramp Inside Crosswalk 1	N/A	Yes	Ramp Inside Crosswalk 2	N/A
	Crossing 1 Slope (%)	1.2		Crossing 2 Slope (%)	2.2
	Crossing 1 Cross Slope (%)	5.6		Crossing 2 Cross Slope (%)	3.8
No	Gutter Ponding	Yes	Yes	Curb Slope	1
Yes	Gutter Lip Height (in)	0		Road Run Slope (%)	0.6
Yes	Gutter Run Slope (%)	3.2		Road Cross Slope (%)	0.8
Yes	Gutter Cross Slope (%)	1.7			
Yes	Overall Surface Condition: Acceptable		Yes	Perp Joint Present	Yes
	Cross Gutter Present?	Yes		Spandrel Present?	Yes
	Replace Cross Gutter?	No		Replace Spandrel?	No

Possible Solutions:
Remove & Replace Landing. Gutter Ponding Observed.
