# Access Compliance Report Public Rights-of-Way (Curb Ramps)

Main Street: BEACH\_BLVD Cross Street: MIDWAY\_PL Location: NE

ADA ID: RPRK210929154331 Ramp Type: Type 1 - Perpendicular Diagonal Initial Pass/Fail: Fail Overall Compliance: No Severity Score: 30

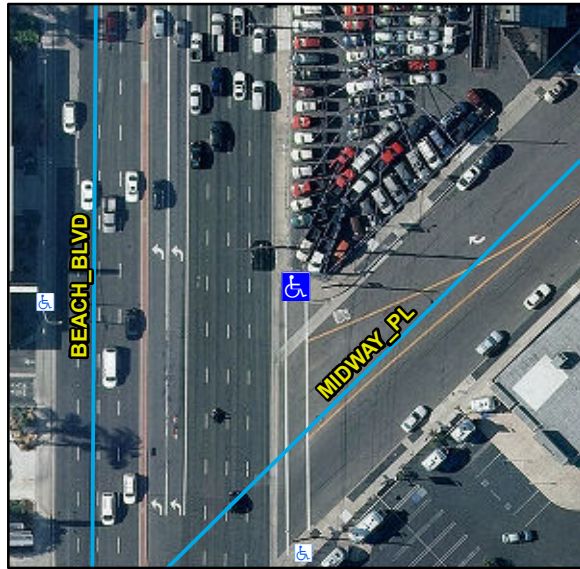
| Compliance | Description | Data | Compliance | Description | Data |
|---|---|---|---|---|---|
| No | Ramp Cross Slope (%) | 11.2 | N/A | Flare Traversable LT | N/A |

Remove & Replace Curb Ramp With Two New Directional Ramps or Equivalent.

R304.5.3, STD 1115

Total Cost: \$ 4000
