# Access Compliance Report Public Rights-of-Way (Curb Ramps)

Main Street: MIDWAY\_PL Cross Street: BEACH\_BLVD Location: SE

ADA ID: RPRK210929154609 Ramp Type: Type 1 - Perpendicular Diagonal Initial Pass/Fail: Fail Overall Compliance: No Severity Score: 30

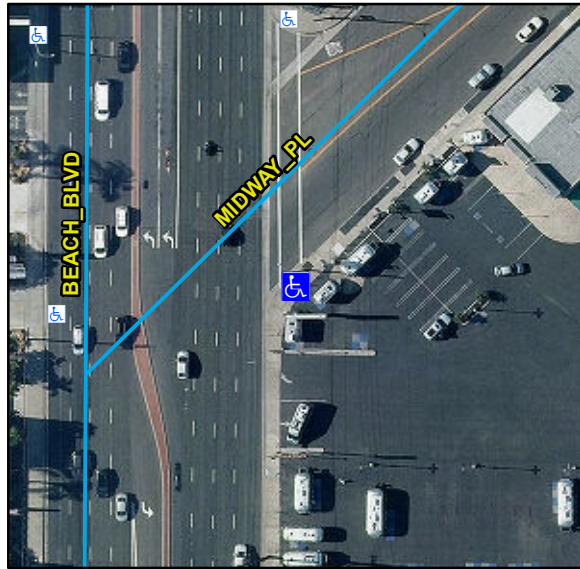
| Compliance | Description | Data | Compliance | Description | Data |
|---|---|---|---|---|---|
| No | Ramp Run Slope (%) | 15.9 | N/A | Flare Slope LT (%) | N/A |

Remove & Replace Curb Ramp With Two New Directional Ramps or Equivalent.

R304.2.2, STD 1115
