# Access Compliance Report Public Rights-of-Way (Curb Ramps)

Main Street: ADAMS\_ST Cross Street: MIDWAY\_PL Location: S

ADA ID: RPRK210929160059 Ramp Type: Type 1 - Perpendicular Diagonal Initial Pass/Fail: Fail Overall Compliance: No Severity Score: 2

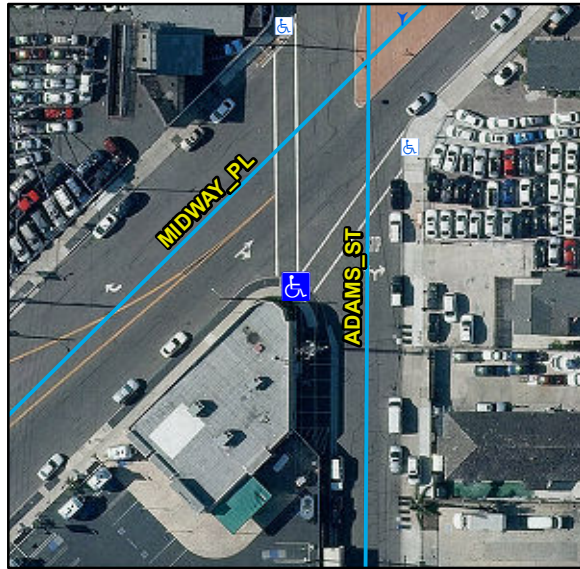
| Compliance | Description | Data | Compliance | Description | Data |
|---|---|---|---|---|---|
| No | Ramp Cross Slope (%) | 3.7 | N/A | Flare Traversable LT | N/A |

Remove & Replace Curb Ramp With Two New Directional Ramps or Equivalent.
