# Access Compliance Report Public Rights-of-Way (Curb Ramps)

Main Street: MIDWAY\_PL Cross Street: ADAMS\_ST Location: W

ADA ID: RPRK210929160635 Ramp Type: Type 1 - Perpendicular Diagonal Initial Pass/Fail: Fail Overall Compliance: No Severity Score: 2

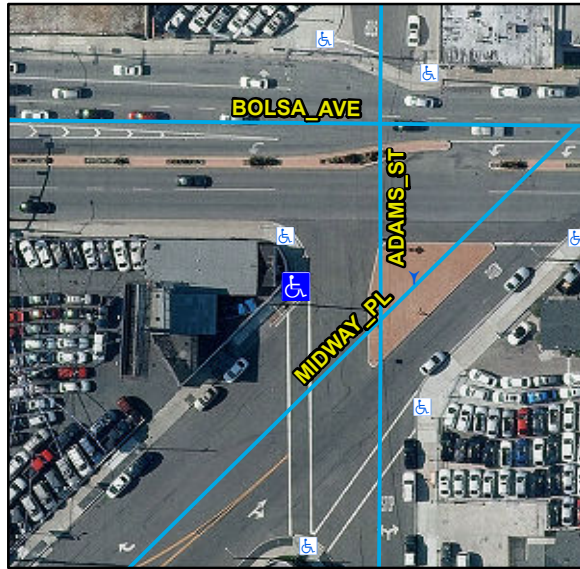
| Compliance | Description | Data | Compliance | Description | Data |
|---|---|---|---|---|---|
| No | Ramp Cross Slope (%) | 2.1 | N/A | Flare Traversable LT | N/A |

Remove & Replace Curb Ramp With Two New Directional Ramps or Equivalent.

R304.2.2, R304.5.3, STD 1115
