# Access Compliance Report Public Rights-of-Way (Curb Ramps)

Main Street: ADAMS\_ST Cross Street: BOLSA\_AVE Location: W

ADA ID: RPRK210929160841 Ramp Type: Type 1 - Perpendicular Diagonal Initial Pass/Fail: Fail Overall Compliance: No Severity Score: 0

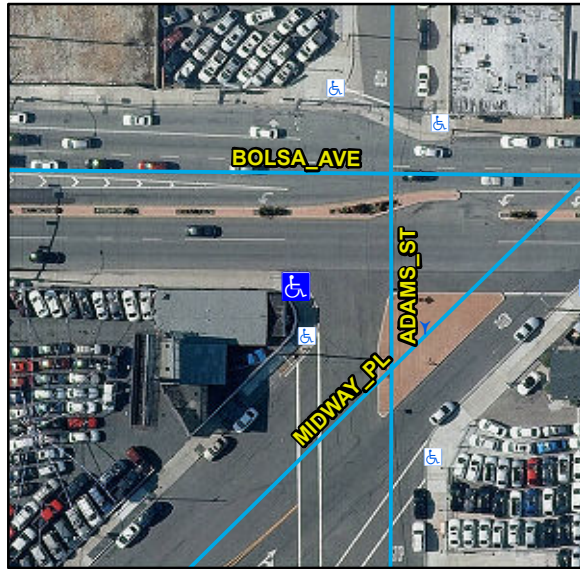
| Compliance | Description | Data | Compliance | Description | Data |
|---|---|---|---|---|---|
| N/A | Ramp Length (in) | 86 | N/A | Flare Type LT | |
| Yes | Ramp Width (in) | 48 | | | N/A |
| Yes | Ramp Run Slope (%) | 2.6 | N/A | Flare Slope LT (%) | N/A |
| Yes | Ramp Cross Slope (%) | 2.1 | N/A | Flare Traversable LT | N/A |

Remove & Replace Curb Ramp With Two New Directional Ramps or Equivalent.

STD 1115
