# Access Compliance Report Public Rights-of-Way (Curb Ramps)

Main Street: BOLSA\_AVE Cross Street: VAN\_BUREN\_ST Location: SE

ADA ID: RPRK210930105602 Ramp Type: Type 1 - Perpendicular Diagonal Initial Pass/Fail: Pass Overall Compliance: No Severity Score: 2

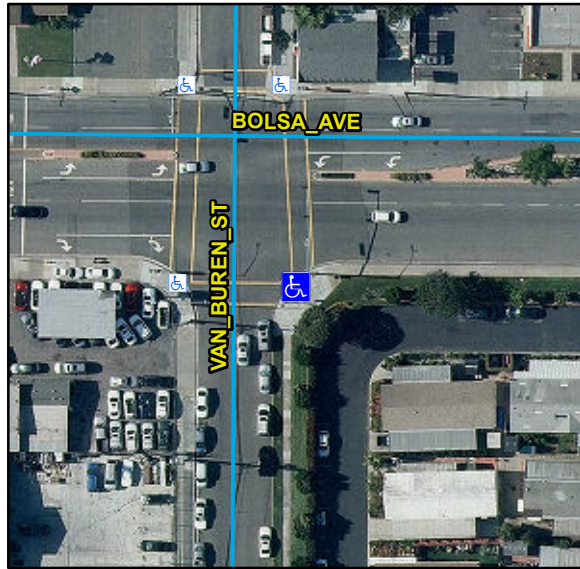
| Compliance | Description | Data | Compliance | Description | Data |
|---|---|---|---|---|---|
| No | Ramp Cross Slope (%) | 3.8 | N/A | Flare Traversable LT | No |
| Yes | Gutter Ponding | No | No | Curb Slope | 7.8 |

Remove & Replace Curb Ramp With Two New Directional Ramps or Equivalent. Utility Present.

R304.2.2, R304.5.3, STD 1115
