# Access Compliance Report Public Rights-of-Way (Curb Ramps)

Main Street: VAN\_BUREN\_ST Cross Street: BOLSA\_AVE Location: NE

ADA ID: RPRK210930110302 Ramp Type: Type 1 - Perpendicular Diagonal Initial Pass/Fail: Pass Overall Compliance: No Severity Score: 2

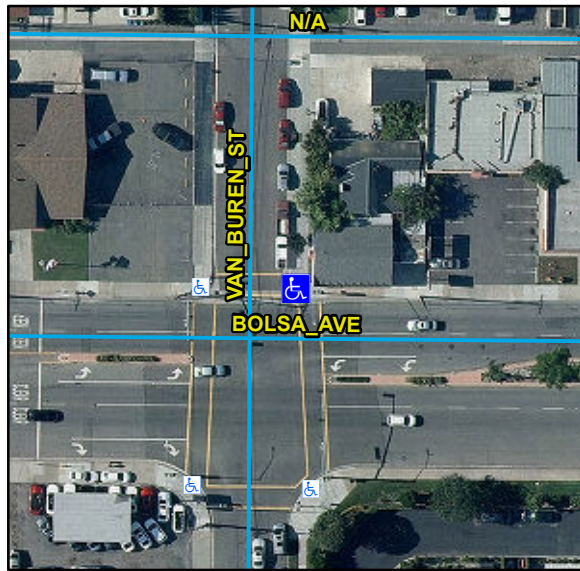
| Compliance | Description | Data | Compliance | Description | Data |
|---|---|---|---|---|---|
| No | Landing Cross Slope (%) | 2.1 | Yes | DWS Provided | Yes |
| Yes | Gutter Ponding | No | No | Curb Slope | 6 |
| No | Gutter Cross Slope (%) | 3 | | | |

Remove & Replace Curb Ramp With Two New Directional Ramps or Equivalent. Remove & Replace Gutter. Utility Present.

R304.2.2, R204.3, R304.5.3, STD 1115
