# Access Compliance Report Public Rights-of-Way (Curb Ramps)

Main Street: BOLSA\_AVE Cross Street: VAN\_BUREN\_ST Location: NW

ADA ID: RPRK210930110927 Ramp Type: Type 1 - Perpendicular Diagonal Initial Pass/Fail: Pass Overall Compliance: No Severity Score: 16

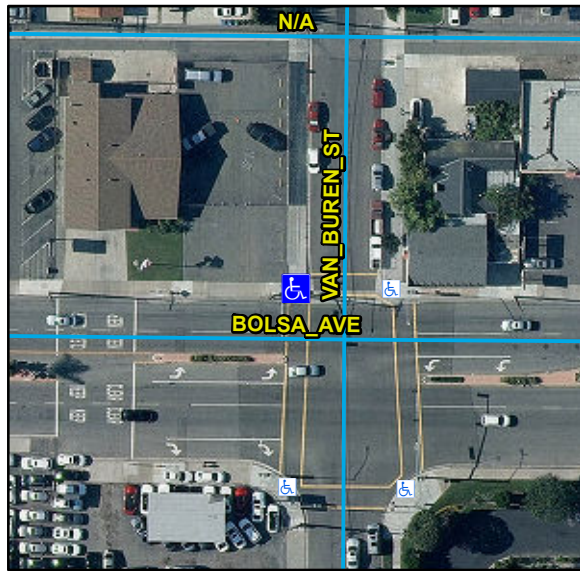
| Compliance | Description | Data | Compliance | Description | Data |
|---|---|---|---|---|---|
| No | Ramp Cross Slope (%) | 2.2 | N/A | Flare Traversable LT | No |
| No | Landing Width (in) | N/A | N/A | Flare Slope RT (%) | 7.7 |
| No | Landing Run Slope (%) | N/A | N/A | Flare Traversable RT | No |
| No | Landing Cross Slope (%) | N/A | Yes | DWS Provided | Yes |
| No | Gutter Run Slope (%) | 6.5 | | Road Cross Slope (%) | 2.8 |
| No | Gutter Cross Slope (%) | 2.1 | | | |

Remove & Replace Curb Ramp With Two New Directional Ramps or Equivalent. Restripe Crosswalk. Remove & Replace Gutter. Utility Present.

R304.5.3, R304.2.1, R304.2.2-Perp, R304.3.2-Para, R207.1, R304.5.4, STD 1115
