# Access Compliance Report Public Rights-of-Way (Curb Ramps)

Main Street: N/A Cross Street: MCFADDEN\_AVE Location: N

ADA ID: RPRK210930113410 Ramp Type: Type 1 - Perpendicular Diagonal Initial Pass/Fail: Fail Overall Compliance: No Severity Score: 16

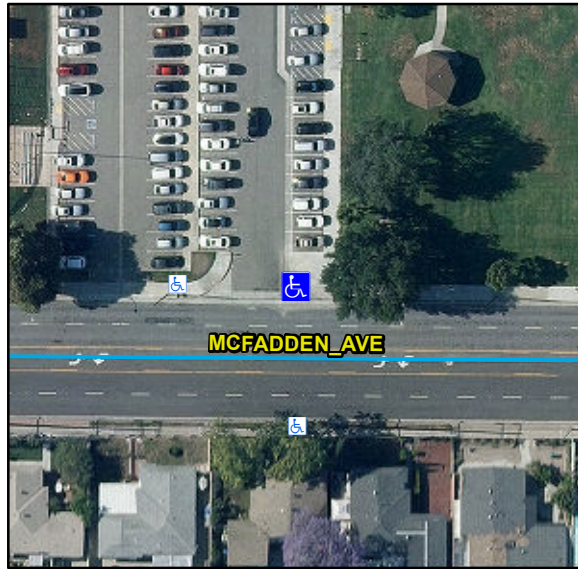
| Compliance | Description | Data | Compliance | Description | Data |
|---|---|---|---|---|---|
| No | Ramp Run Slope (%) | 9.6 | N/A | Flare Slope LT (%) | N/A |

**Remove & Replace Curb Ramp With Two New Directional Ramps or Equivalent.**

**R304.2.2, STD 1115**
