# Access Compliance Report Public Rights-of-Way (Curb Ramps)

Main Street: WILSON\_ST Cross Street: MCFADDEN\_AVE Location: NE

ADA ID: RPRK210930113857 Ramp Type: Type 1 - Perpendicular Diagonal Initial Pass/Fail: Fail Overall Compliance: No Severity Score: 32

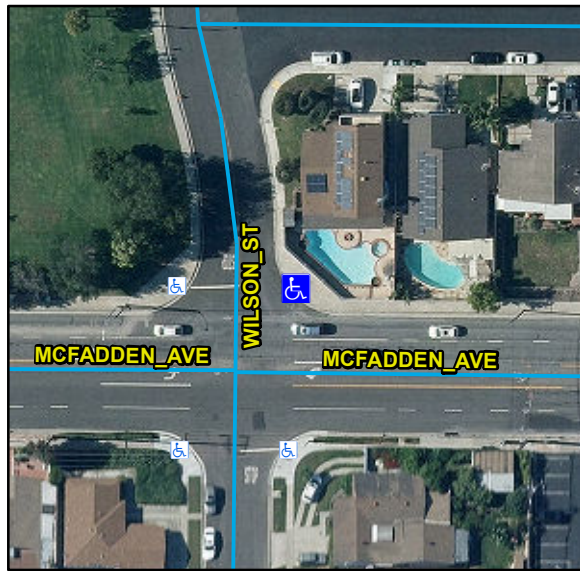
| Compliance | Description | Data | Compliance | Description | Data |
|---|---|---|---|---|---|
| No | Ramp Run Slope (%) | 13.6 | N/A | Flare Slope LT (%) | N/A |
| No | Ramp Cross Slope (%) | 2.6 | N/A | Flare Traversable LT | N/A |

Remove & Replace Curb Ramp With Two New Directional Ramps or Equivalent.

R304.2.2, R204.3, R304.5.3, STD 1115
