# Access Compliance Report Public Rights-of-Way (Curb Ramps)

| Main Street: SANDUSKY_LN | Cross Street: MCFADDEN_AVE | Location: SW |

| ADA ID: RPRK210930114358 | Ramp Type: Type 1 - Perpendicular Diagonal Initial Pass/Fail: Fail | Overall Compliance: No | Severity Score: 2 |

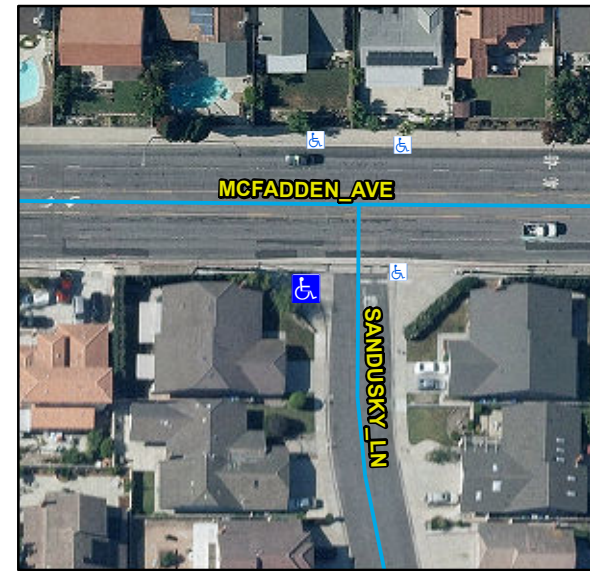
| Compliance | Description | Data | Compliance | Description | Data |
|---|---|---|---|---|---|
| No | Ramp Cross Slope (%) | 3.3 | N/A | Flare Traversable LT | N/A |

**Remove & Replace Curb Ramp With Two New Directional Ramps or Equivalent.**

**R304.2.2, R304.5.3, STD 1115**
