# Access Compliance Report Public Rights-of-Way (Curb Ramps)

Main Street: MCFADDEN\_AVE Cross Street: SANDUSKY\_LN Location: SE

ADA ID: RPRK210930114624 Ramp Type: Type 1 - Perpendicular Diagonal Initial Pass/Fail: Fail Overall Compliance: No Severity Score: 15

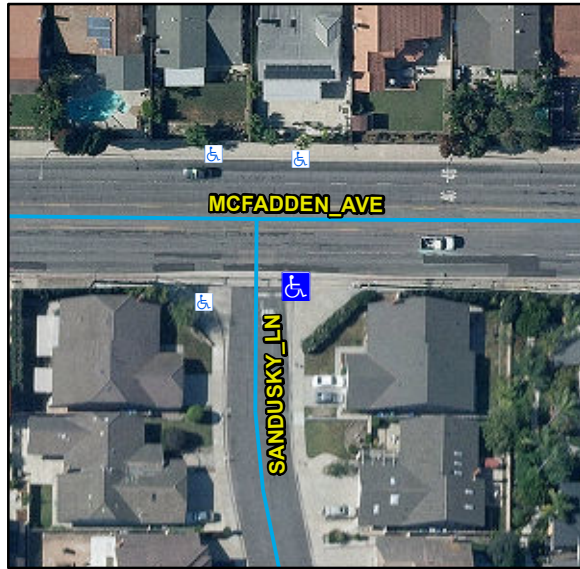
| Compliance | Description | Data | Compliance | Description | Data |
|---|---|---|---|---|---|
| No | Ramp Run Slope (%) | 10.4 | N/A | Flare Slope LT (%) | N/A |

**Remove & Replace Curb Ramp With Two New Directional Ramps or Equivalent.**

**R304.2.2, STD 1115**
