# Access Compliance Report Public Rights-of-Way (Curb Ramps)

Main Street: PETERS\_AVE Cross Street: WILSON\_ST Location: NW

ADA ID: RPRK210930115706 Ramp Type: Type 1 - Perpendicular Diagonal Initial Pass/Fail: Pass Overall Compliance: No Severity Score: 20

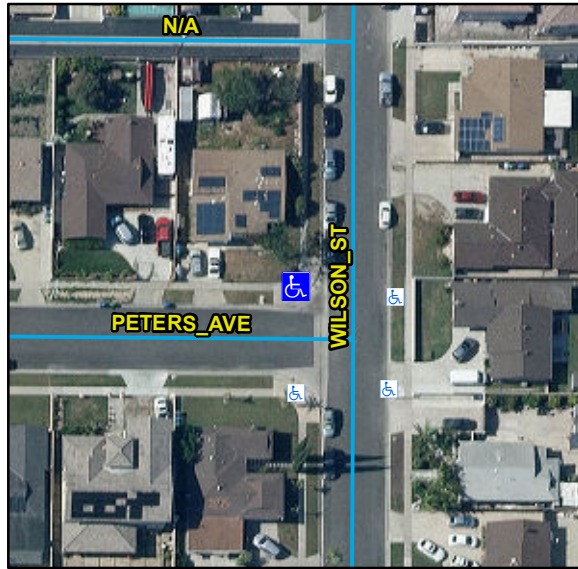
| Compliance | Description | Data | Compliance | Description | Data |
|---|---|---|---|---|---|
| No | Landing Cross Slope (%) | N/A | No | DWS Provided | No |
| No | Gutter Lip Height (in) | 0.25 | | Road Run Slope (%) | 1.7 |

Remove & Replace Curb Ramp With Two New Directional Ramps or Equivalent. Grind Gutter Lip.
