# Access Compliance Report

## Public Rights-of-Way

### (Curb Ramps)

Main Street: WILSON\_ST Cross Street: PETERS\_AVE Location: SW

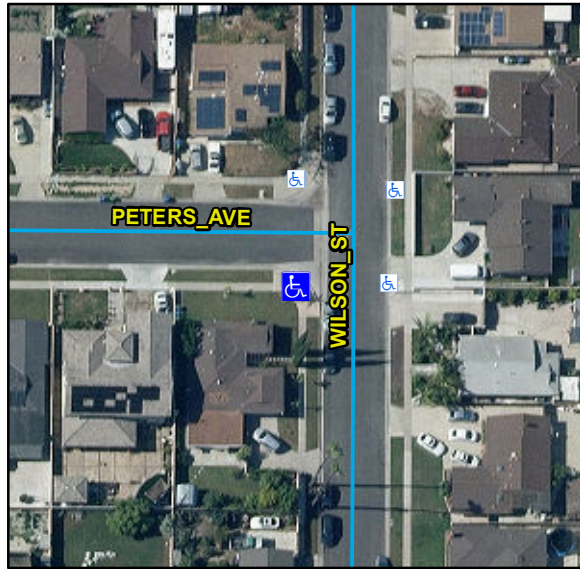
ADA ID: RPRK210930115941 Ramp Type: Type 1 - Perpendicular Diagonal Initial Pass/Fail: Fail Overall Compliance: No Severity Score: 16

| Compliance | Description | Data | Compliance | Description | Data |
|---|---|---|---|---|---|
| No | Ramp Run Slope (%) | 11.2 | N/A | Flare Slope LT (%) | N/A |
| No | Gutter Lip Height (in) | 0.25 | | Road Run Slope (%) | 0.7 |

**Remove & Replace Curb Ramp With Two New Directional Ramps or Equivalent. Grind Gutter Lip.**

**R204.3, R304.2.2, R302.7.2, STD 1115**
