# Access Compliance Report Public Rights-of-Way (Curb Ramps)

Main Street: FLIGHT\_AVE Cross Street: WILSON\_ST Location: NW

ADA ID: RPRK210930120415 Ramp Type: Type 1 - Perpendicular Diagonal Initial Pass/Fail: Fail Overall Compliance: No Severity Score: 30

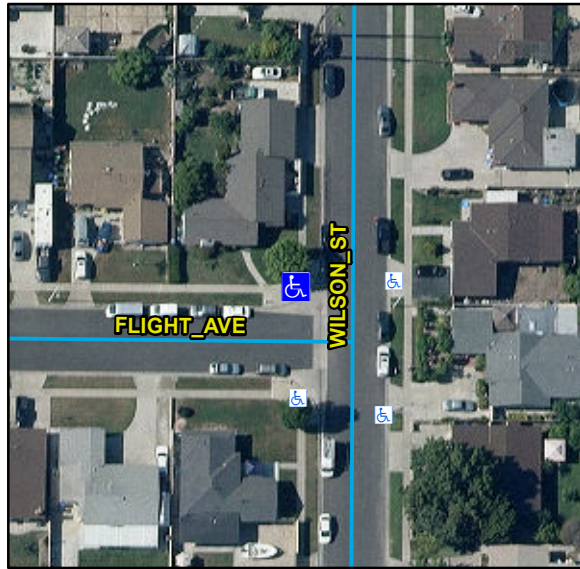
| Compliance | Description | Data | Compliance | Description | Data |
|---|---|---|---|---|---|
| No | Ramp Cross Slope (%) | 12.2 | N/A | Flare Traversable LT | N/A |
| No | Gutter Lip Height (in) | 0.25 | | Road Run Slope (%) | 2.3 |

**Remove & Replace Curb Ramp With Two New Directional Ramps or Equivalent. Grind Gutter Lip.**

**R204.3, R304.5.3, R302.7.2, STD 1115**
