# Access Compliance Report Public Rights-of-Way (Curb Ramps)

Main Street: WILSON\_ST Cross Street: FLIGHT\_AVE Location: SW

ADA ID: RPRK210930120609 Ramp Type: Type 1 - Perpendicular Diagonal Initial Pass/Fail: Fail Overall Compliance: No Severity Score: 15

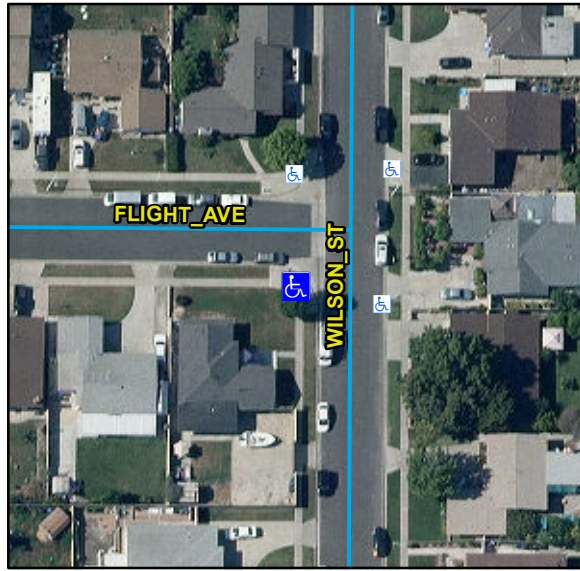
| Compliance | Description | Data | Compliance | Description | Data |
|---|---|---|---|---|---|
| No | Ramp Run Slope (%) | 11.2 | N/A | Flare Slope LT (%) | N/A |
| No | Gutter Lip Height (in) | 0.25 | | Road Run Slope (%) | 1.8 |

**Remove & Replace Curb Ramp With Two New Directional Ramps or Equivalent.**

**R304.2.2, R204.3, R302.7.2, STD 1115**
