# Access Compliance Report Public Rights-of-Way (Curb Ramps)

Main Street: WORTHY\_DR Cross Street: WILSON\_ST Location: NW

ADA ID: RPRK210930121140 Ramp Type: Type 1 - Perpendicular Diagonal Initial Pass/Fail: Fail Overall Compliance: No Severity Score: 2

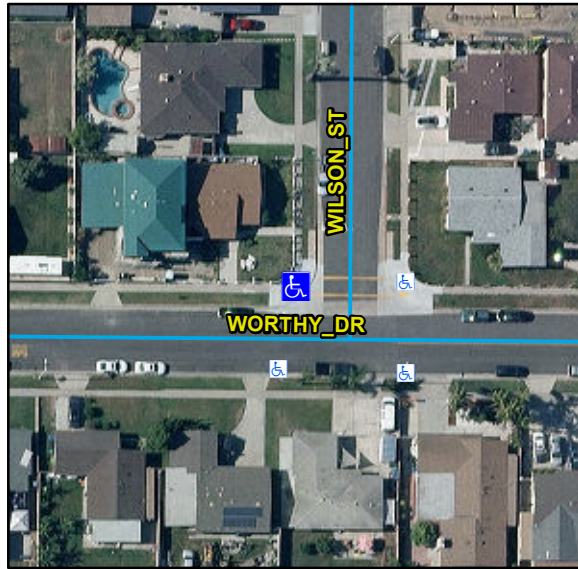
R304.2.2, R304.5.3, STD 1115

| Compliance | Description | Data | Compliance | Description | Data |
|---|---|---|---|---|---|
| No | Ramp Cross Slope (%) | 2.9 | N/A | Flare Traversable LT | N/A |

Remove & Replace Curb Ramp With Two New Directional Ramps or Equivalent. Restripe Crosswalk.
