# Access Compliance Report Public Rights-of-Way (Curb Ramps)

Main Street: WILSON\_ST Cross Street: WORTHY\_DR Location: NE

ADA ID: RPRK210930121401 Ramp Type: Type 1 - Perpendicular Diagonal Initial Pass/Fail: Fail Overall Compliance: No Severity Score: 2

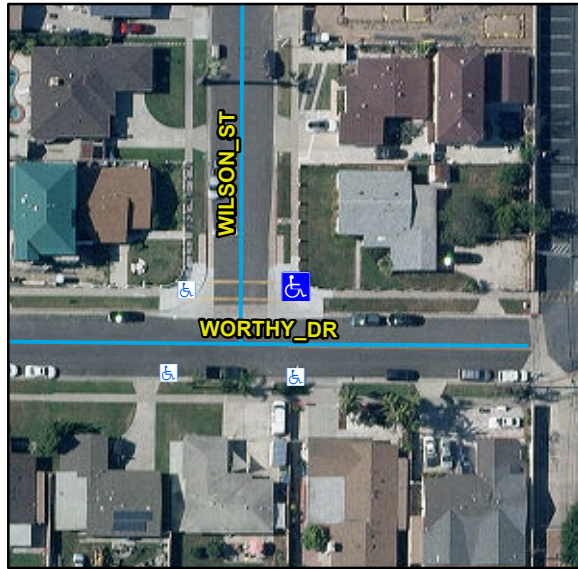
| Compliance | Description | Data | Compliance | Description | Data |
|---|---|---|---|---|---|
| No | Ramp Cross Slope (%) | 3.7 | N/A | Flare Traversable LT | N/A |
| N/A | Gutter Ponding | N/A | No | Curb Slope | 11.5 |

**Remove & Replace Curb Ramp With Two New Directional Ramps or Equivalent. Restripe Crosswalk.**

**R304.2.2, R304.5.3, STD 1115**
