# Access Compliance Report Public Rights-of-Way (Curb Ramps)

Main Street: JEFFERSON\_ST Cross Street: WORTHY\_DR Location: NE

ADA ID: RPRK210930121814 Ramp Type: Type 1 - Perpendicular Diagonal Initial Pass/Fail: Fail Overall Compliance: No Severity Score: 15

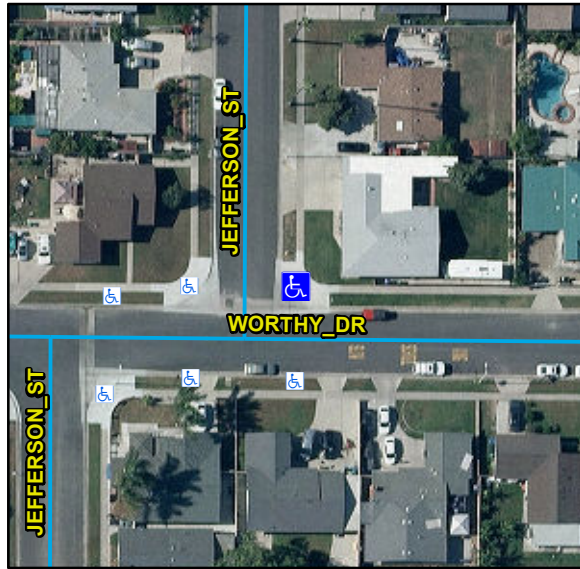
| Compliance | Description | Data | Compliance | Description | Data |
|---|---|---|---|---|---|
| No | Ramp Run Slope (%) | 8.9 | N/A | Flare Slope LT (%) | N/A |

**Remove & Replace Curb Ramp With Two New Directional Ramps or Equivalent.**

**R304.2.2, STD 1115**
