# Access Compliance Report Public Rights-of-Way (Curb Ramps)

Main Street: **WORTHY\_DR** Cross Street: **JEFFERSON\_ST** Location: **NW**

ADA ID: **RPRK210930121947** Ramp Type: **Type 1 - Perpendicular Diagonal** Initial Pass/Fail: **Fail** Overall Compliance: **No** Severity Score: **16**

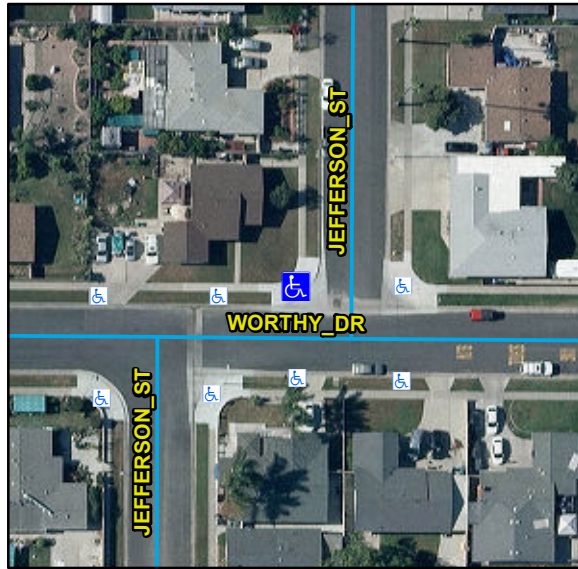
| Compliance | Description | Data | Compliance | Description | Data |
|---|---|---|---|---|---|
| <b>No</b> | Ramp Run Slope (%) | <b>10.8</b> | <b>N/A</b> | Flare Slope LT (%) | <b>N/A</b> |
| <b>No</b> | Ramp Cross Slope (%) | <b>2.7</b> | <b>N/A</b> | Flare Traversable LT | <b>N/A</b> |

**Remove & Replace Curb Ramp With Two New Directional Ramps or Equivalent.**

**R304.2.2, R304.5.3, STD 1115**
