# Access Compliance Report Public Rights-of-Way (Curb Ramps)

Main Street: WORTHY\_DR Cross Street: JEFFERSON\_ST Location: SE

ADA ID: RPRK210930122217 Ramp Type: Type 1 - Perpendicular Diagonal Initial Pass/Fail: Fail Overall Compliance: No Severity Score: 15

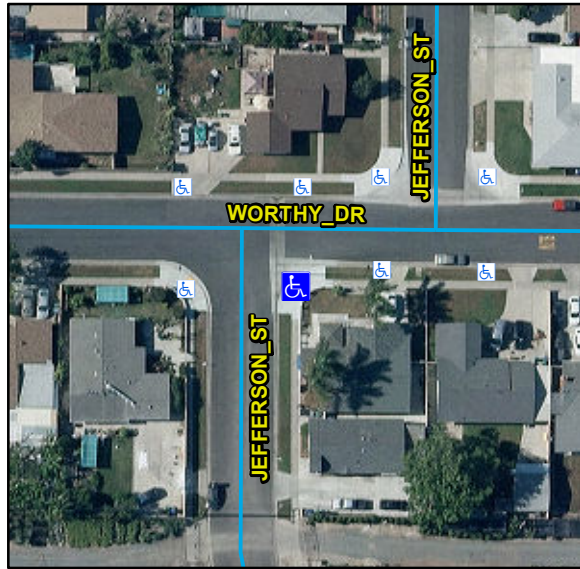
| Compliance | Description | Data | Compliance | Description | Data |
|---|---|---|---|---|---|
| No | Ramp Run Slope (%) | 10.4 | N/A | Flare Slope LT (%) | N/A |
| N/A | Gutter Ponding | N/A | No | Curb Slope | 14.5 |

**Remove & Replace Curb Ramp With Two New Directional Ramps or Equivalent.**

**R304.2.2, STD 1115**
