# Access Compliance Report Public Rights-of-Way (Curb Ramps)

Main Street: WORTHY\_DR Cross Street: MONROE\_ST Location: SE

ADA ID: RPRK210930122839 Ramp Type: Type 1 - Perpendicular Diagonal Initial Pass/Fail: Fail Overall Compliance: No Severity Score: 30

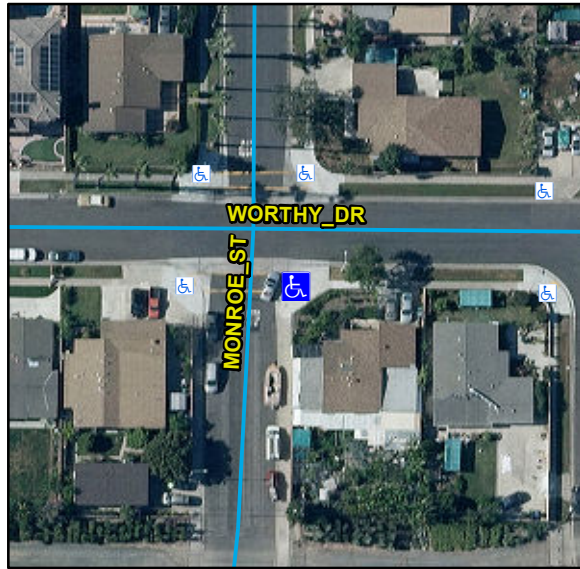
| Compliance | Description | Data | Compliance | Description | Data |
|---|---|---|---|---|---|
| No | Ramp Cross Slope (%) | 11.1 | N/A | Flare Traversable LT | N/A |

Remove & Replace Curb Ramp With Two New Directional Ramps or Equivalent.

R304.2.2, R304.5.3, STD 1115
