# Access Compliance Report Public Rights-of-Way (Curb Ramps)

Main Street: MONROE\_ST Cross Street: WORTHY\_DR Location: SW

ADA ID: RPRK210930123156 Ramp Type: Type 1 - Perpendicular Diagonal Initial Pass/Fail: Fail Overall Compliance: No Severity Score: 15

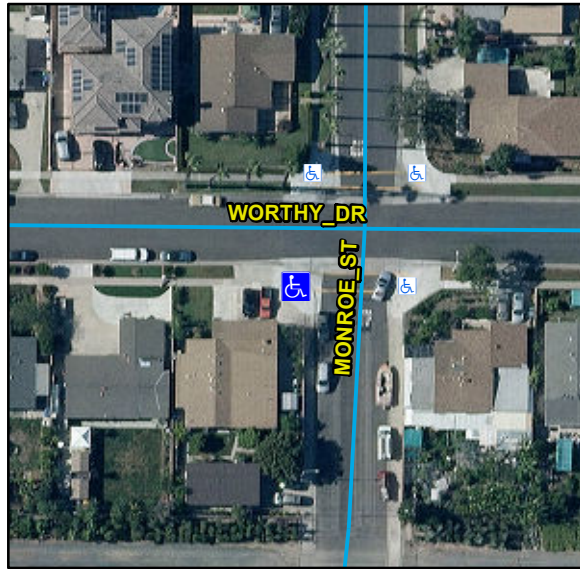
| Compliance | Description | Data | Compliance | Description | Data |
|---|---|---|---|---|---|
| No | Ramp Run Slope (%) | 11.3 | N/A | Flare Slope LT (%) | N/A |

**Remove & Replace Curb Ramp With Two New Directional Ramps or Equivalent.**

**R304.2.2, STD 1115**
