# Access Compliance Report Public Rights-of-Way (Curb Ramps)

Main Street: MONROE\_ST Cross Street: WORTHY\_DR Location: NE

ADA ID: RPRK210930123815 Ramp Type: Type 1 - Perpendicular Diagonal Initial Pass/Fail: Fail Overall Compliance: No Severity Score: 15

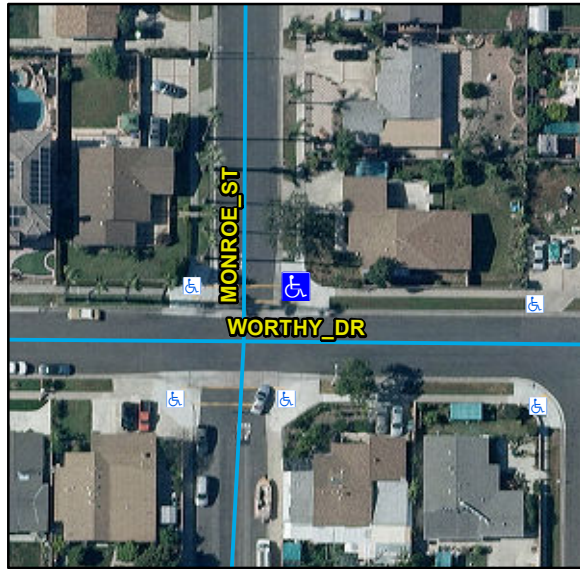
R304.2.2, STD 1115

| Compliance | Description | Data | Compliance | Description | Data |
|---|---|---|---|---|---|
| No | Ramp Run Slope (%) | 9.1 | N/A | Flare Slope LT (%) | N/A |

Remove & Replace Curb Ramp With Two New Directional Ramps or Equivalent. Restripe Crosswalk.
