# Access Compliance Report Public Rights-of-Way (Curb Ramps)

Main Street: FLIGHT\_AVE Cross Street: VAN\_BUREN\_ST Location: SE

ADA ID: RPRK210930125031 Ramp Type: Type 1 - Perpendicular Diagonal Initial Pass/Fail: Fail Overall Compliance: No Severity Score: 2

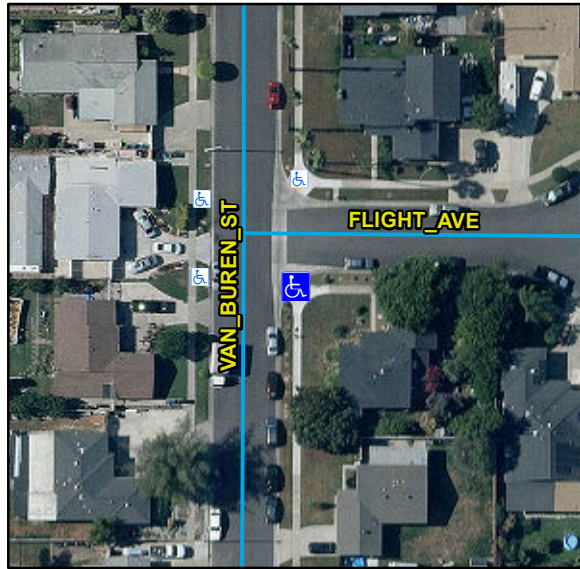
| Compliance | Description | Data | Compliance | Description | Data |
|---|---|---|---|---|---|
| No | Ramp Cross Slope (%) | 4.7 | N/A | Flare Traversable LT | N/A |

Remove & Replace Curb Ramp With Two New Directional Ramps or Equivalent.

R304.5.3, STD 1115
